# Manhole Inspection Summary

Manhole # S21K1\_016MH

Insp Date: **4/25/08 9:34 AM**

**Location** Address: **3010 stranden rd**

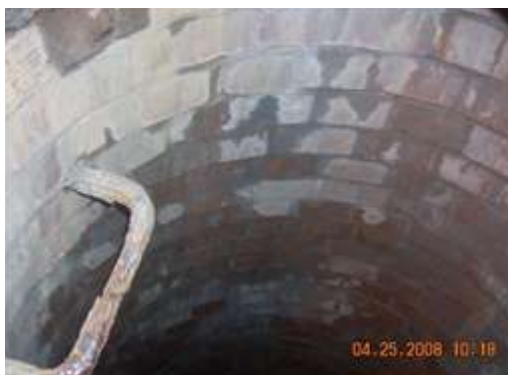
Defect 4

Infiltration: ☐ None ☒ **Joint** ☐ Cracks ☐ Mortar ☐ Roots ☒ **Wall**

infiltration @ corbel wall

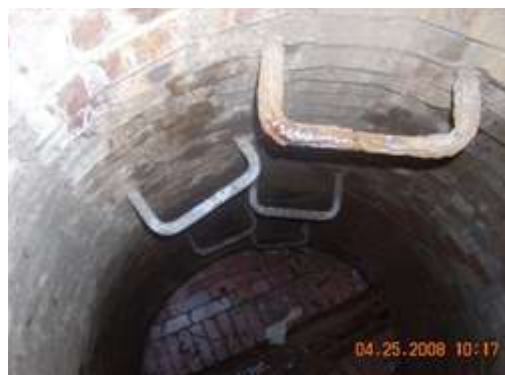
Defect 3

Count: **5** Missing: **0** ☒ **Corroded**

corroded steps

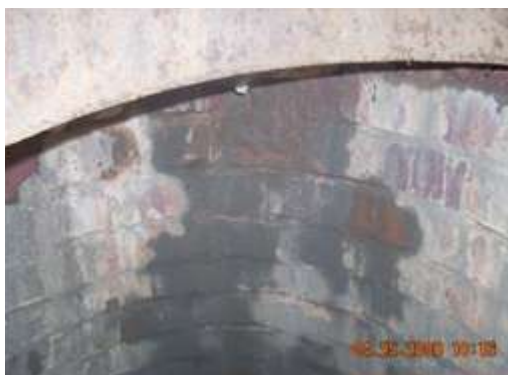
Defect 2

infiltration @ corbel/frame joint

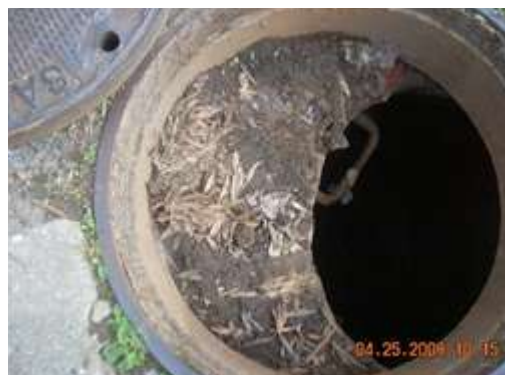
Defect 1

Offset: **12** (in.)

frame offset

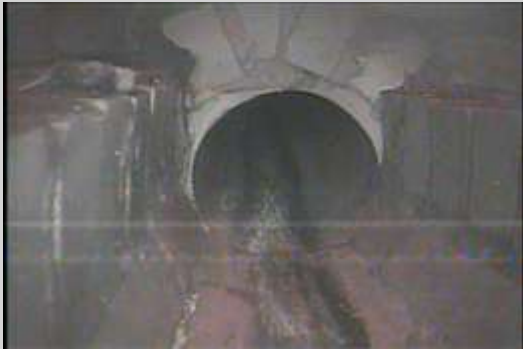
12 O'Clock Outflow

Pipe Height: **8.4** (in.) Rod and Bar (Angled)  
Pipe Material: **Clay** ☐ Pipe Lined  
Invert Depth: **9.73** (ft.) Flow Characteristics: **Slow**  
Deposits: ☒ None ☐ Mud ☐ Sludge ☐ Debris ☐ Grease  
Silt Depth: **0** (in.) Deposits Extent:  
Infiltration: **None** Pipe Seal Cond: **Sound**

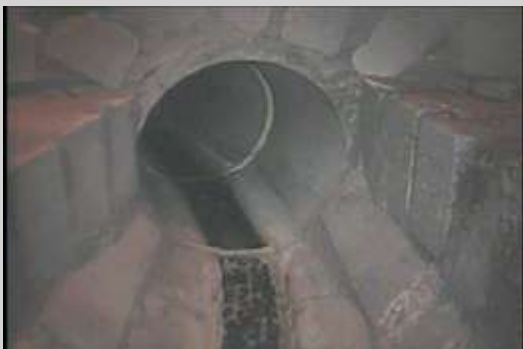
4 O'Clock Inflow

Pipe Height: **7.2** (in.) Rod and Bar (Angled)  
Pipe Material: **Clay** ☐ Pipe Lined  
Invert Depth: **9.40** (ft.) Flow Characteristics: **Slow**  
Deposits: ☒ None ☐ Mud ☐ Sludge ☐ Debris ☐ Grease  
Silt Depth: **0** (in.) Deposits Extent:  
Infiltration: **None** Pipe Seal Cond: **Sound**

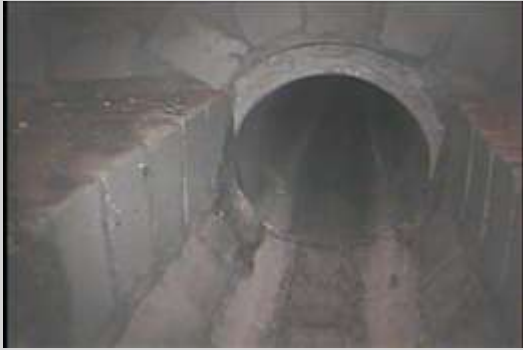
6 O'Clock Inflow

Infiltration: **None** Pipe Seal Cond: **Sound**
